UPRR Composite Tie History & In-Track Experience

FRA Track & Railroad
Workplace Safety Symposium
April 5-7, 2022, St. Louis, MO

Composite Ties: Performance, Design and Testing Guidelines

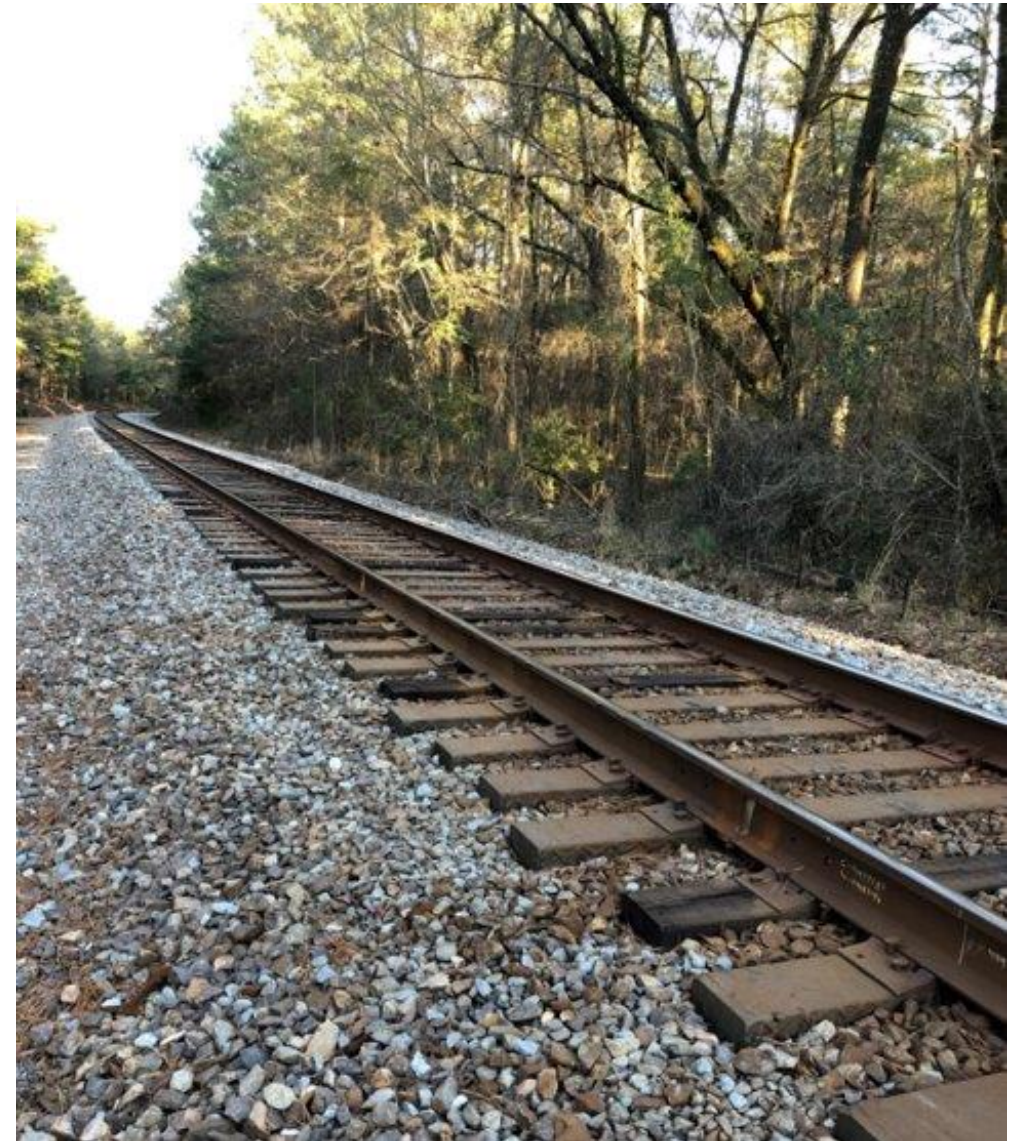
Stamps, AR Installation 2002

- Over 1 BGT since Installation
- No wood tie intervention for two cycles
- Makes hardwood available for other projects
- Disposal cost do not exist

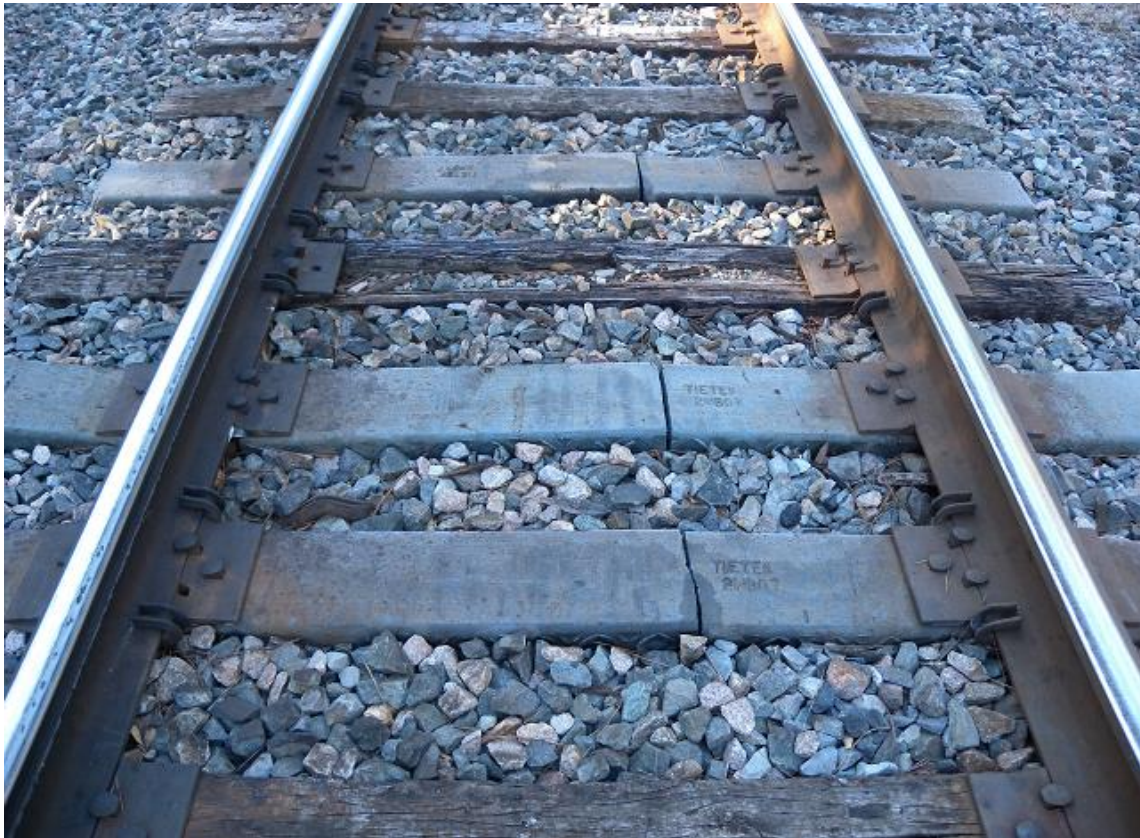
Center Breaks – Bending Stress

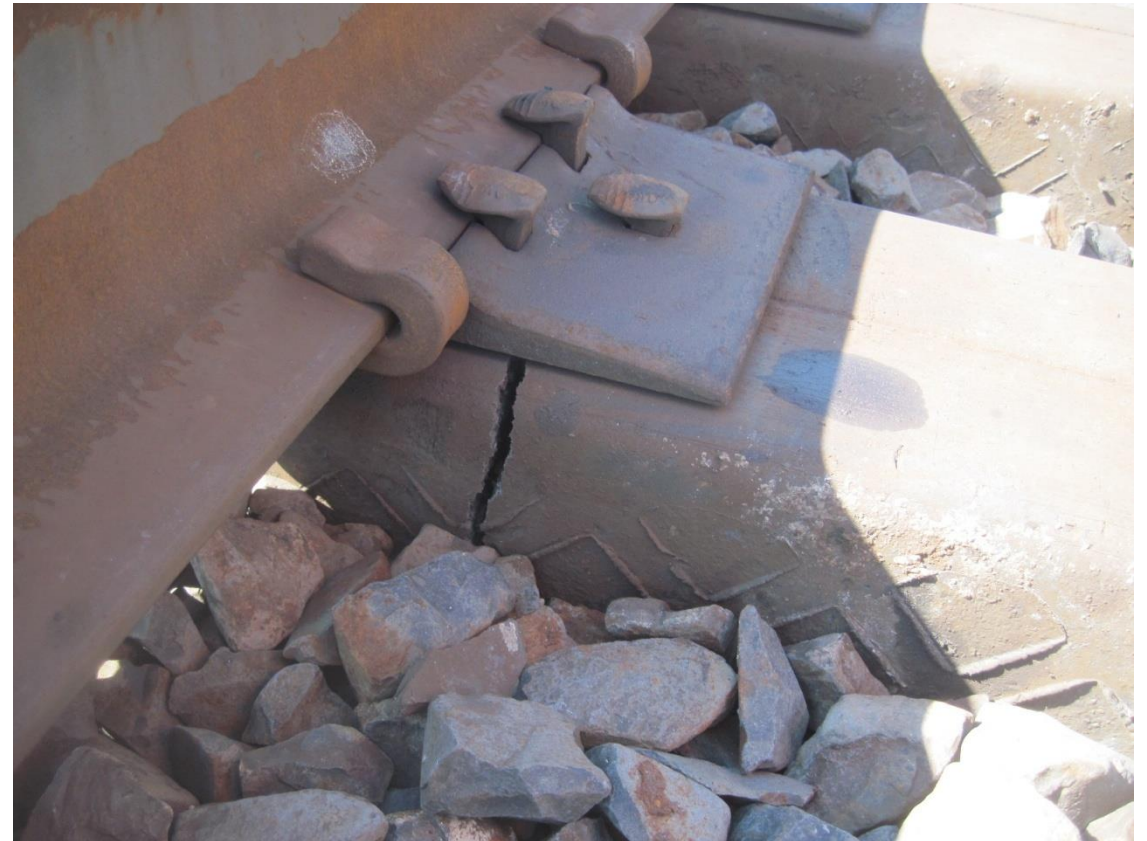
Spike Area – Concentrated Loading

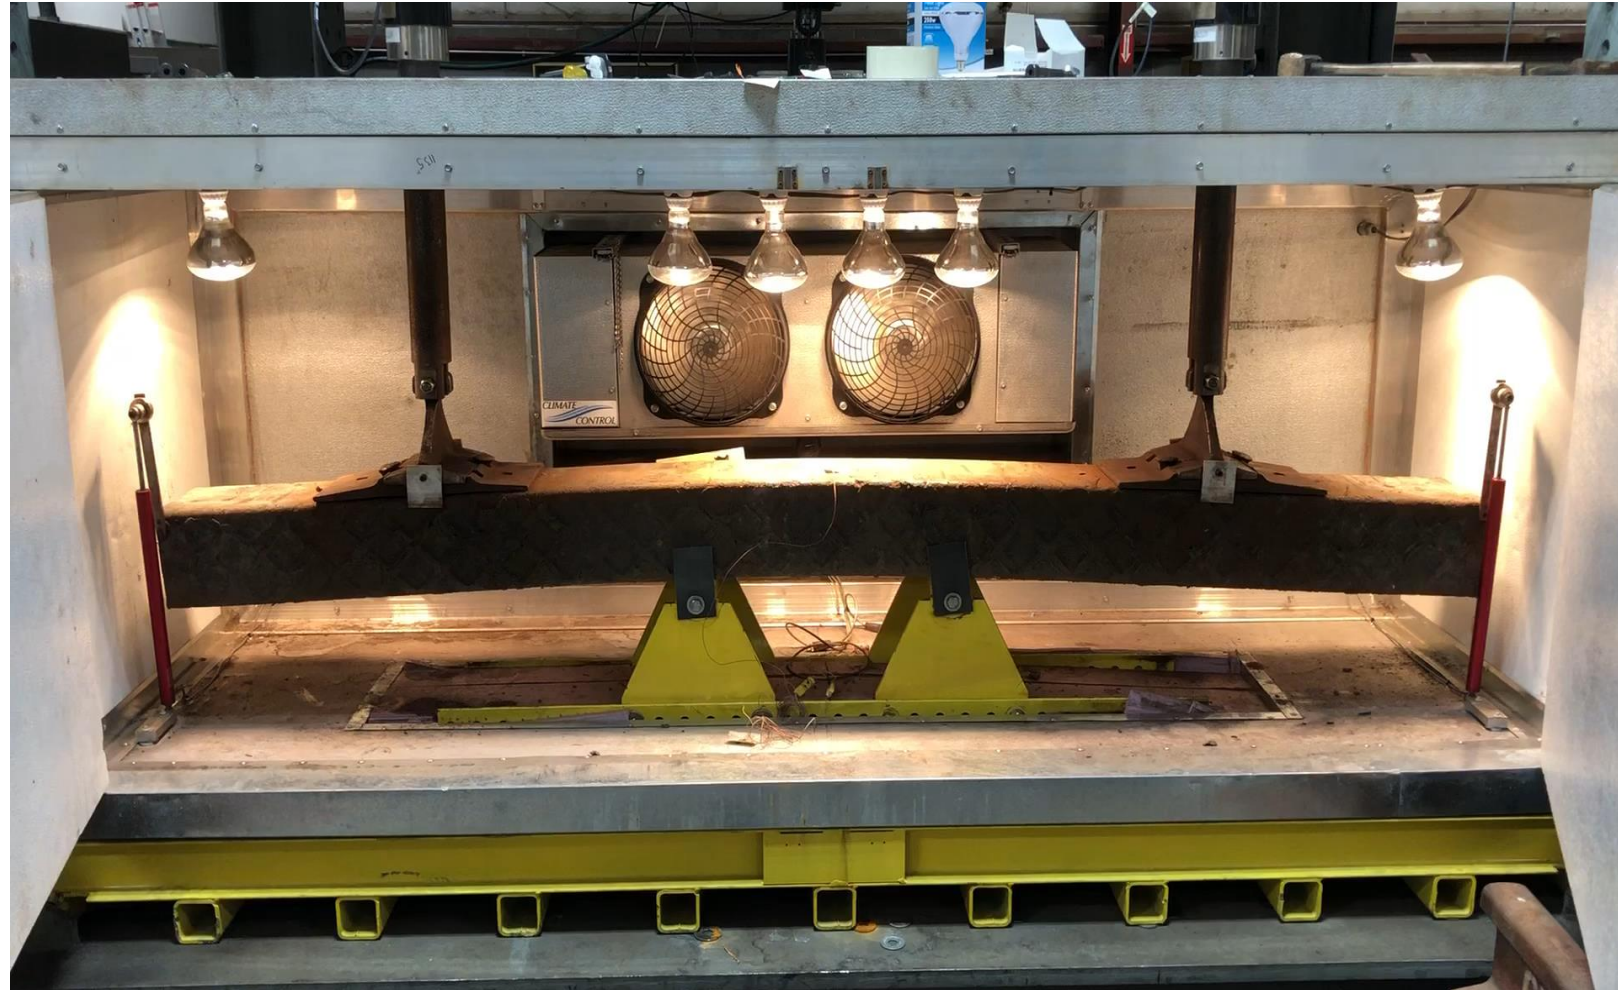
Temperature Chamber Deflection Test

- Designed to mimic extreme field loading (Thermal and Mechanical)
- Center bound tie
- Monitor:
 - Bending strain
 - Tie temp (top/bottom)
 - End deflection
 - Rail seat deflection
 - Rail seat load

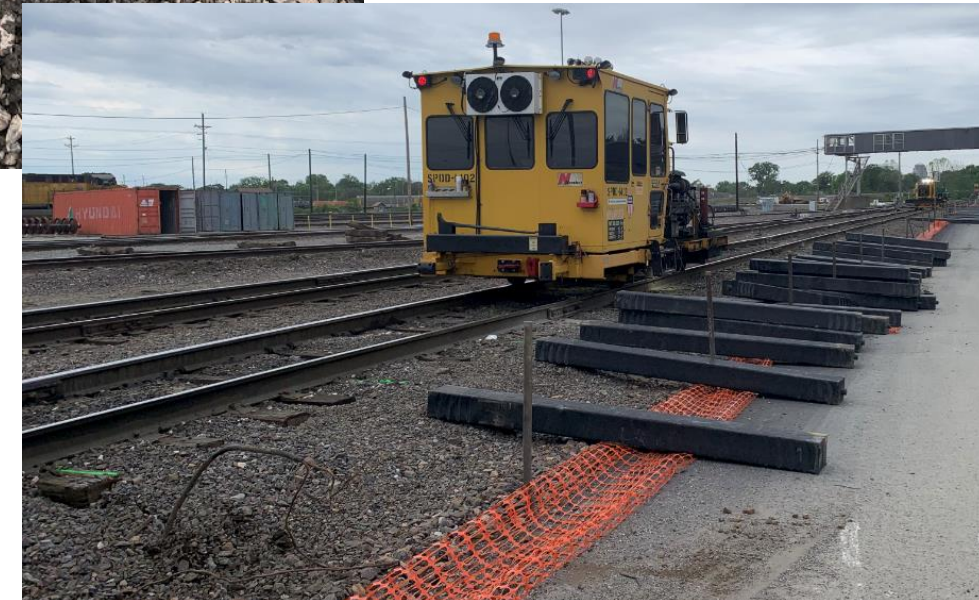
- Chester Sub 1500+ ties (200 MGT)
 - Mixed install, very controlled
 - Instrumented ties
 - Small section of cold spiked, all others pre-drilled
 - Two vendors
 - 1 failure center break
- Little Rock Sub 4500 ties (80 MGT)
 - 100% predrilled
 - Controlled install
 - One vendor
 - 1 failure installation issue
- A&S Yard 450 ties (2021 Install)
 - Yard grade ties
 - Muddy location & sharp curve
 - Mixed fastener types
 - 4 failures in muddy subgrade

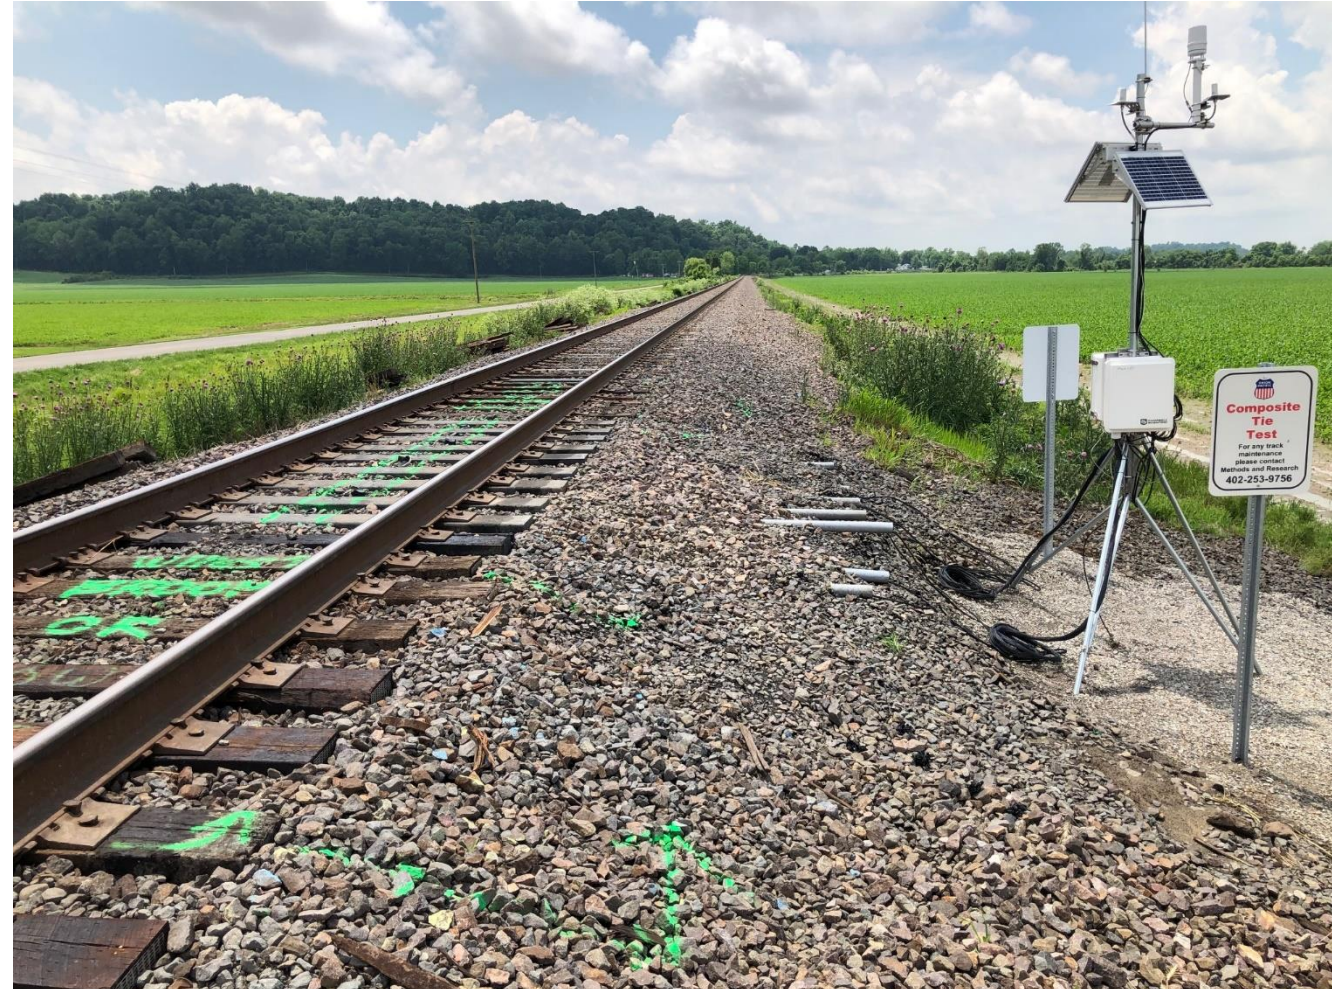
In Track Tests (Chester Sub)

- 2 suppliers ties instrumented
- Install date roughly May 20th, 2020
- Constant readings of center bending strain & top & bottom tie temp
- Installed roughly 1500 ties, very controlled installation

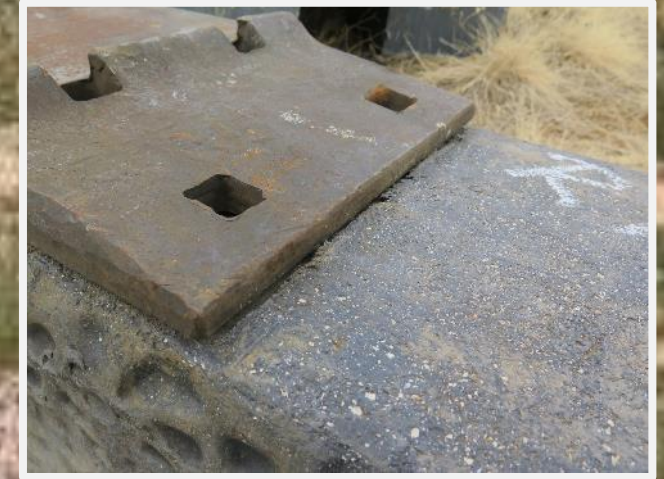
In-Track Performance Evaluation

- **FAST and revenue service experience**
 - Four types of EPC ties since 2015
 - Two main failure modes were identified
 - Minimal plate cutting
 - In-track failure rates and modes inconsistent

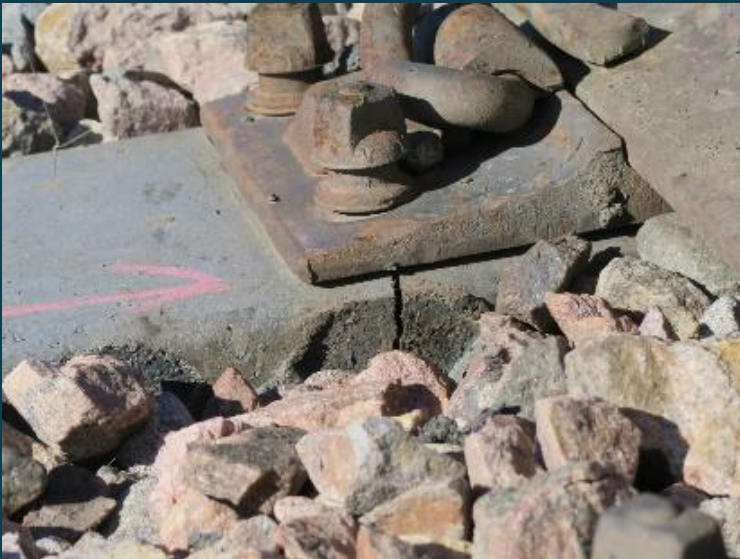
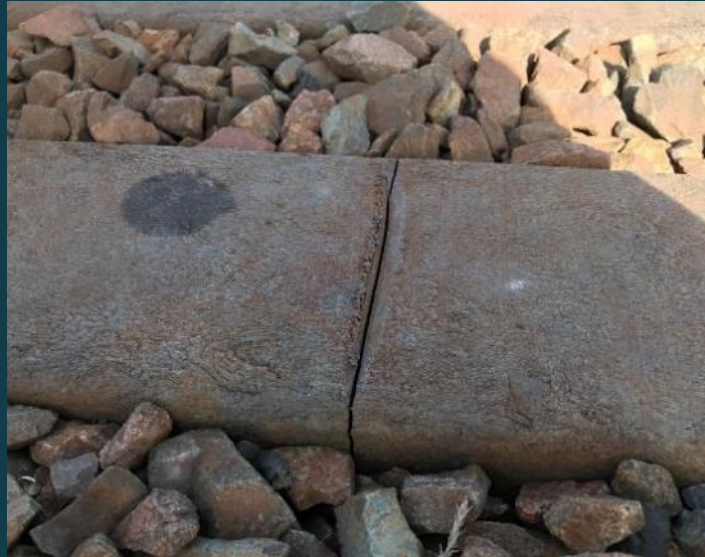
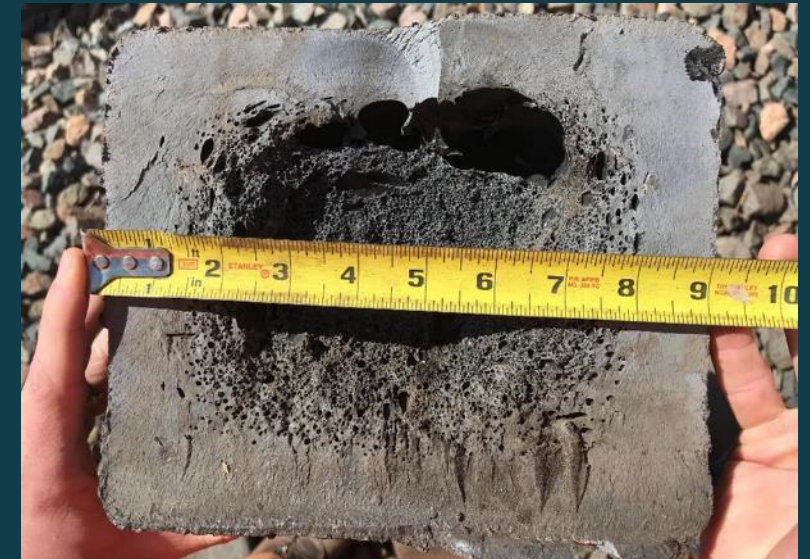
Two Failure Modes Identified

- **Spike hole cracking and center cracking**
 - Typically, not seen on wood ties
 - Fourteen percent of the EPC ties experienced these two failure modes within 218 MGT at FAST
 - In-track measured bending strains were far less than tie ultimate strength, indicating a fatigue failure

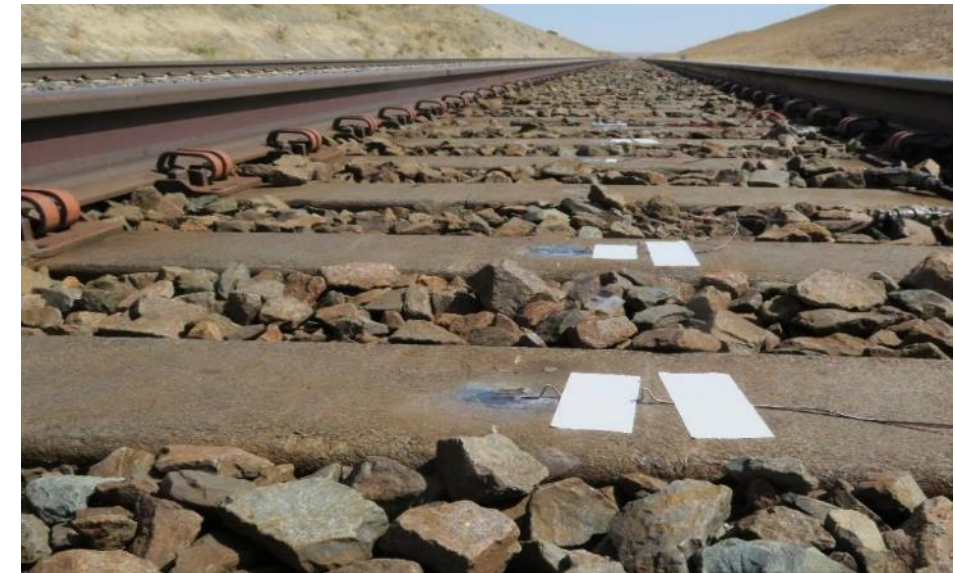
In-track Loading Environment

- **In-track center bending strain**
 - Strain gages on the top surface of ties
 - Data collected in revenue service and at FAST

Tie Type	MOE (ksi)	Avg. Center Strain ($\mu\epsilon$)
FAST Measurements		
A	212	1701.5
B	133	1778.5
D	405	1471.9
Revenue Service Measurements		
A	212	1338.8
C	181	1364.2

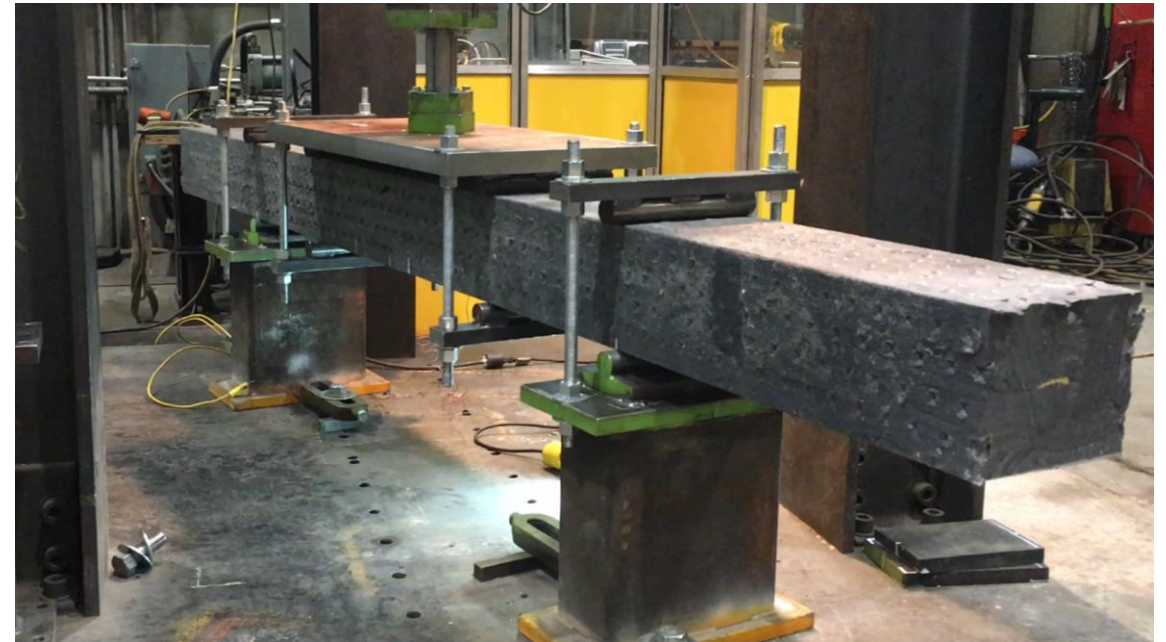
Proposed Laboratory Fatigue Test

- Four-point bending test to generate constant bending moment in the middle section of the tie
- Clamps at four span supports to eliminate creep effect
- 1.5 million fatigue cycles

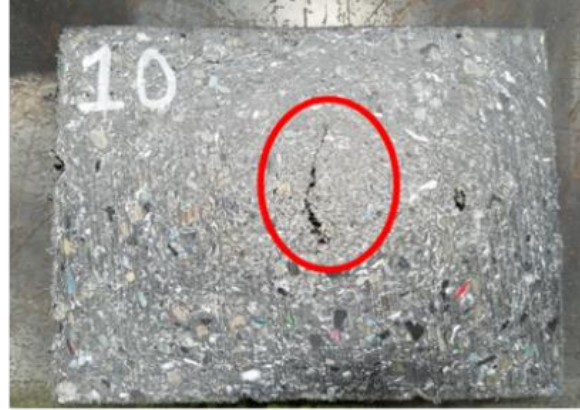
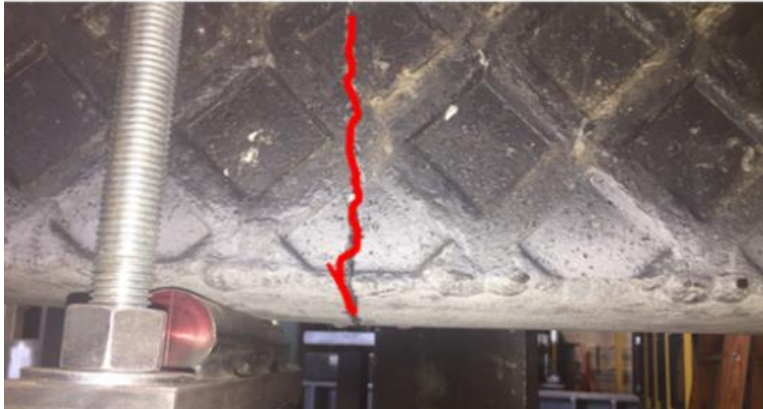
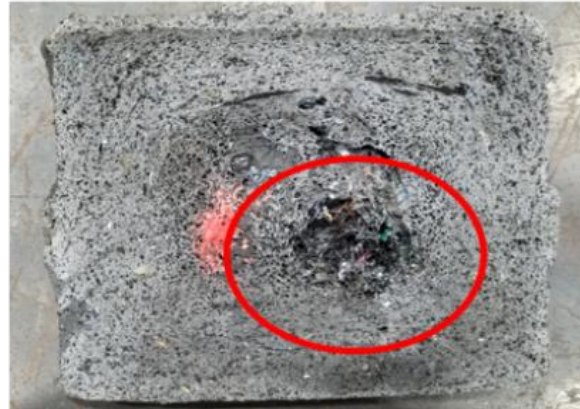
Test Results and Analysis

- **Nine EPC ties were tested with the test setup**
 - Two broke with a center crack similar to that observed in track
 - Successfully identified EPC ties with internal defects without overloading good quality ties

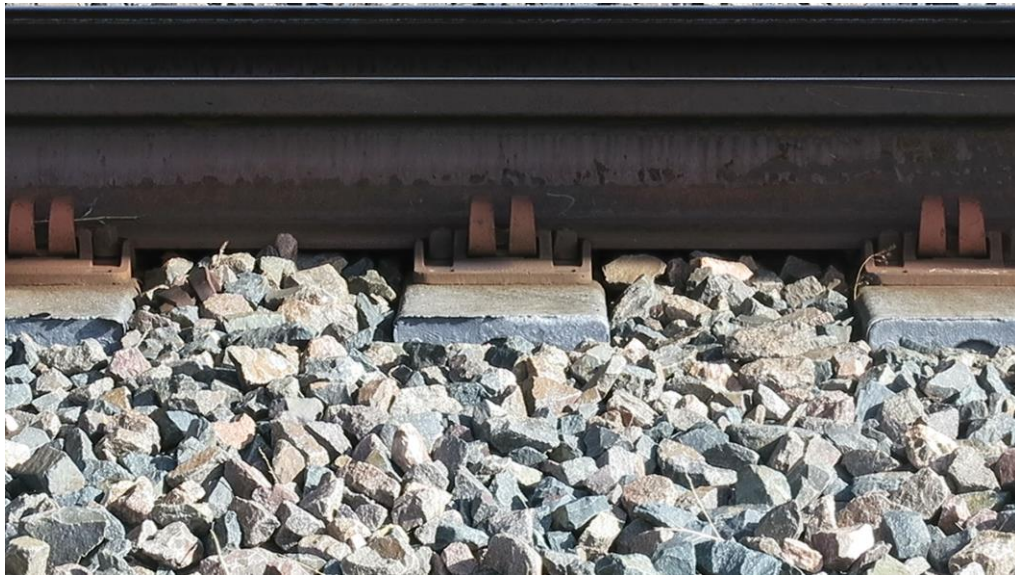
8am - Tie Temp 50 degrees

- Temperature increase and temperature differential in ties caused gage widening
